# Heat exchanger inspection — Unit 4

Report date: Oct 9, 2026

What was inspected    Plate heat exchanger, primary circuit, Unit 4  
Prepared by            J. Martin  
Location                Plant room B2  
Customer or job        Northfield Facilities · job 2410-07

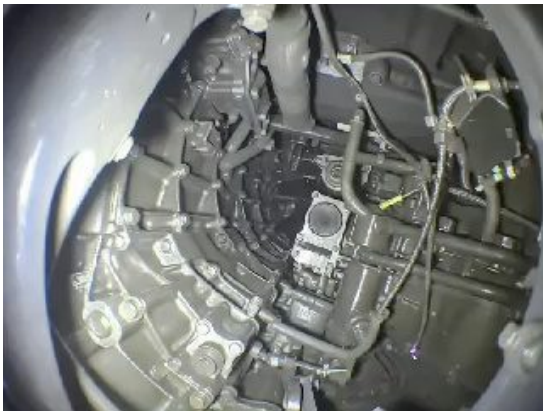
**Figure 1.**

Still from the inspection video at the inlet nozzle; surface sound, minor discolouration only.

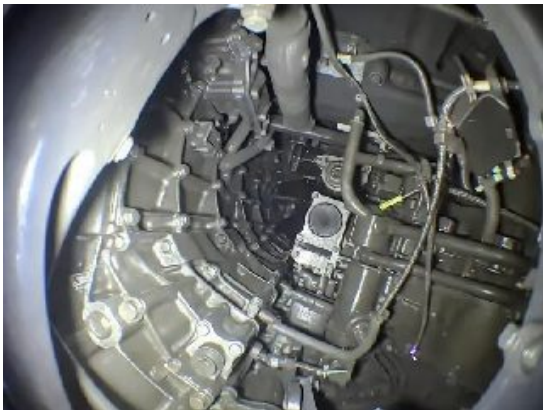
**Figure 2.**

**Priority (author):** Fix soon

Dried residue below the gasket line; no active drip during the inspection.

**Next action:** Replace the gasket set; order part before the shutdown.

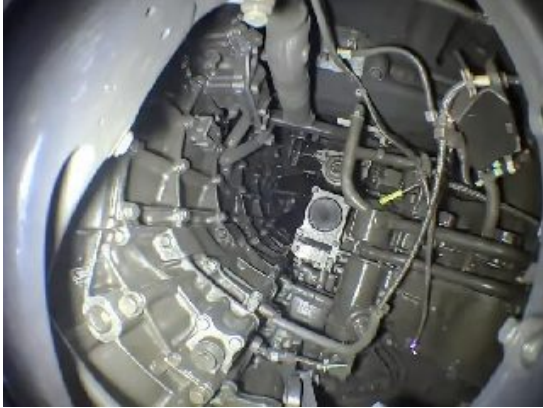
**Figure 3.**

**Priority (author): Monitor**

Light calcium scale on the inlet side; flow channel narrowed by roughly a third at plate 14.

**Next action:** Chemical descale at the next shutdown; recheck in 6 months.
